ENVIRONMENTAL VARIABILITY OF MODAL PROPERTIES

Phillip J. Cornwell*, Charles R. Farrar**, Scott W. Doebling** and Hoon Sohn***

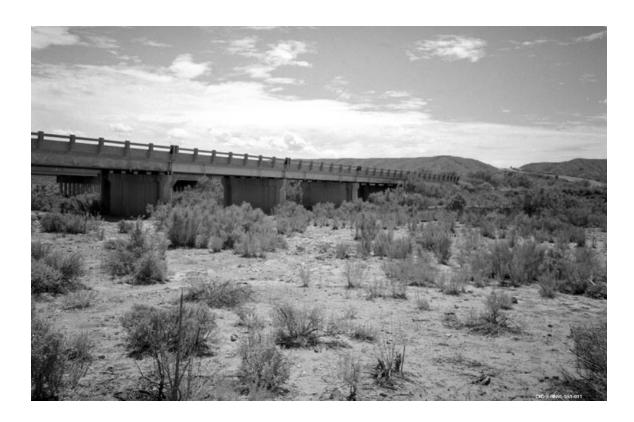
Figure 1 Alamosa Canyon Bridge Near Truth or Consequences, New Mexico

Several field tests of the Alamosa Canyon Bridge have been performed to study various aspects of applying vibration–based damage detection methods to a real world *in situ* structure. This bridge is aligned primarily in the north-south direction and is located adjacent to Interstate 25 (I-25) approximately 16 km (10 miles) north of Truth or Consequences, New Mexico. The bridge, as seen from the arroyo it crosses, is shown in Figure 1.

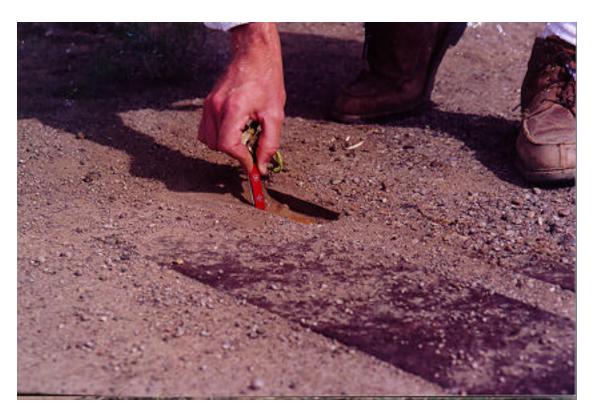
Figure 5 Debris in expansion joint.

side producing the temperature differential across the deck. The expansion joints were filled with debris as shown in Figure 5 and the structure was not free to expand. Therefore, the temperature differential and corresponding thermal expansion altered the boundary conditions of the structure, which then altered the resonant frequencies exhibited by the bridge.
